Oil Spill from a Hydraulic Hose Failure at a Forestry Site

A BioNorth Solutions Case Study

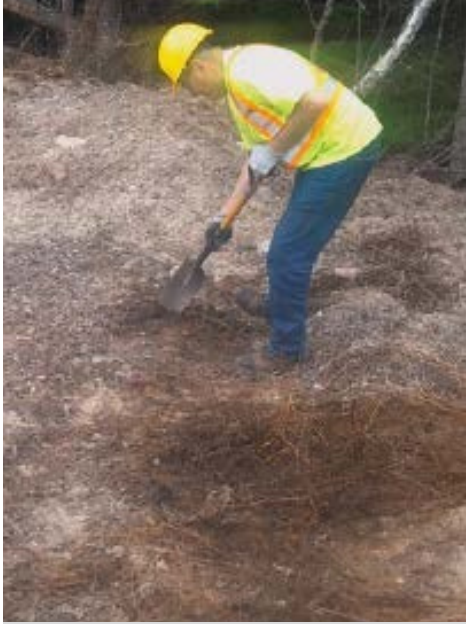
**Application of
Microbiate SG™**

The pictures above show the spill site over a two month period. The left photo displays the spill site being treated with Microbiate SG™. The subsequent photos display the vegetation regrowth over a two month period. This regrowth is a direct result of the result of the application of Microbiate SG™ and the return to healthier, less contaminated soil.

Treatment: Using the accompanying directions, a contractor applied Microbiate SG™ to the contaminated soil. At the time of application, water was added, but not thereafter. The only time the treated area was exposed to water after the time of treatment was from rainfall. Multiple applications were initially recommended, to ensure consistent microbe viability over time at the site.
